October 15, 2020

RE: Site Review of potential harvesting on Airey Face.

Will Halleran, P.Geo.,
Apex Geoscience Consultants Ltd.

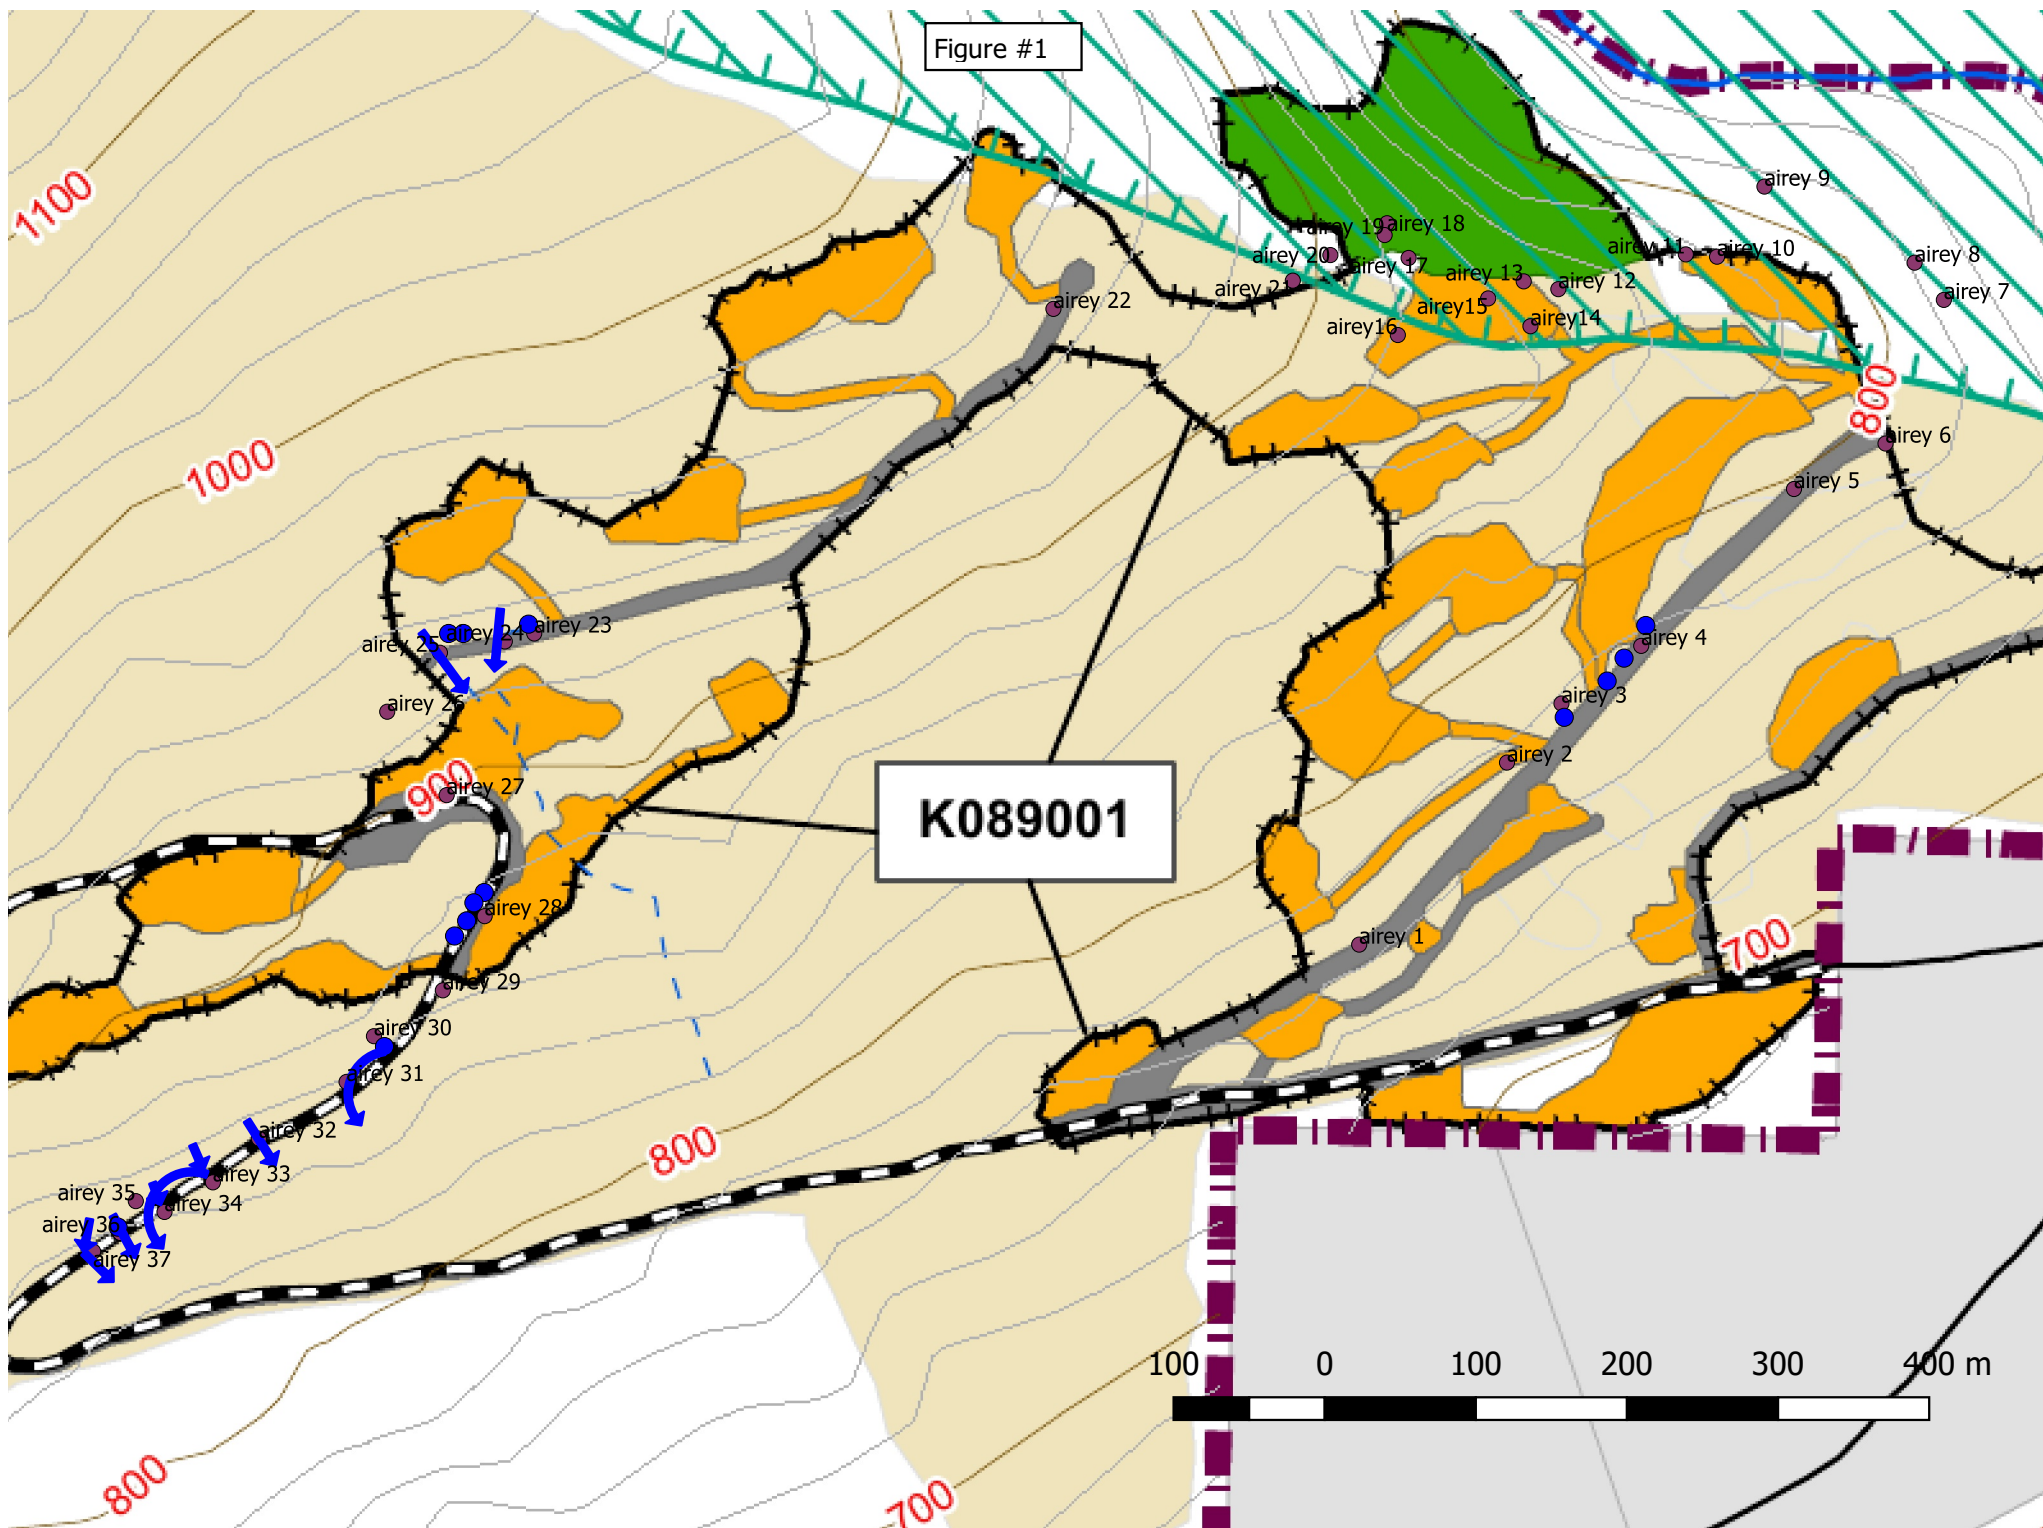
Figure #1

The proposed development, POD's, terrain polygons and observation sites are shown on figure #1.

already been harvested. Streams and springs have been intercepted, diverted and concentrated by the existing road network along the western edge of the proposed development (figure 1). The only POD's mapped in that area are Bowers Brook and possibly Driesser Brook. It is likely that mapped NCD-1A and NCD-1 contribute to Bowers Brook, Driesser Brook appears to be west of the affected drainage.

The skid trails proposed in the western area traverse the drainage pathways. There are no terrain stability concerns, but to avoid impacts to downslope water resource values it is important to maintain current drainage patterns. Any new skid trails should be completely reclaimed after harvesting and inspected to ensure water isn't intercepted or diverted. Current drainage patterns on existing trails should be maintained.
