# Detailed Terrain Stability Field Review

# Proposed Road and portions of proposed blocks in the McFarlane Creek Watershed For Kalesnikoff Lumber Company Ltd.

W. Halleran P. Geo, L.Eng. 2020-04-08

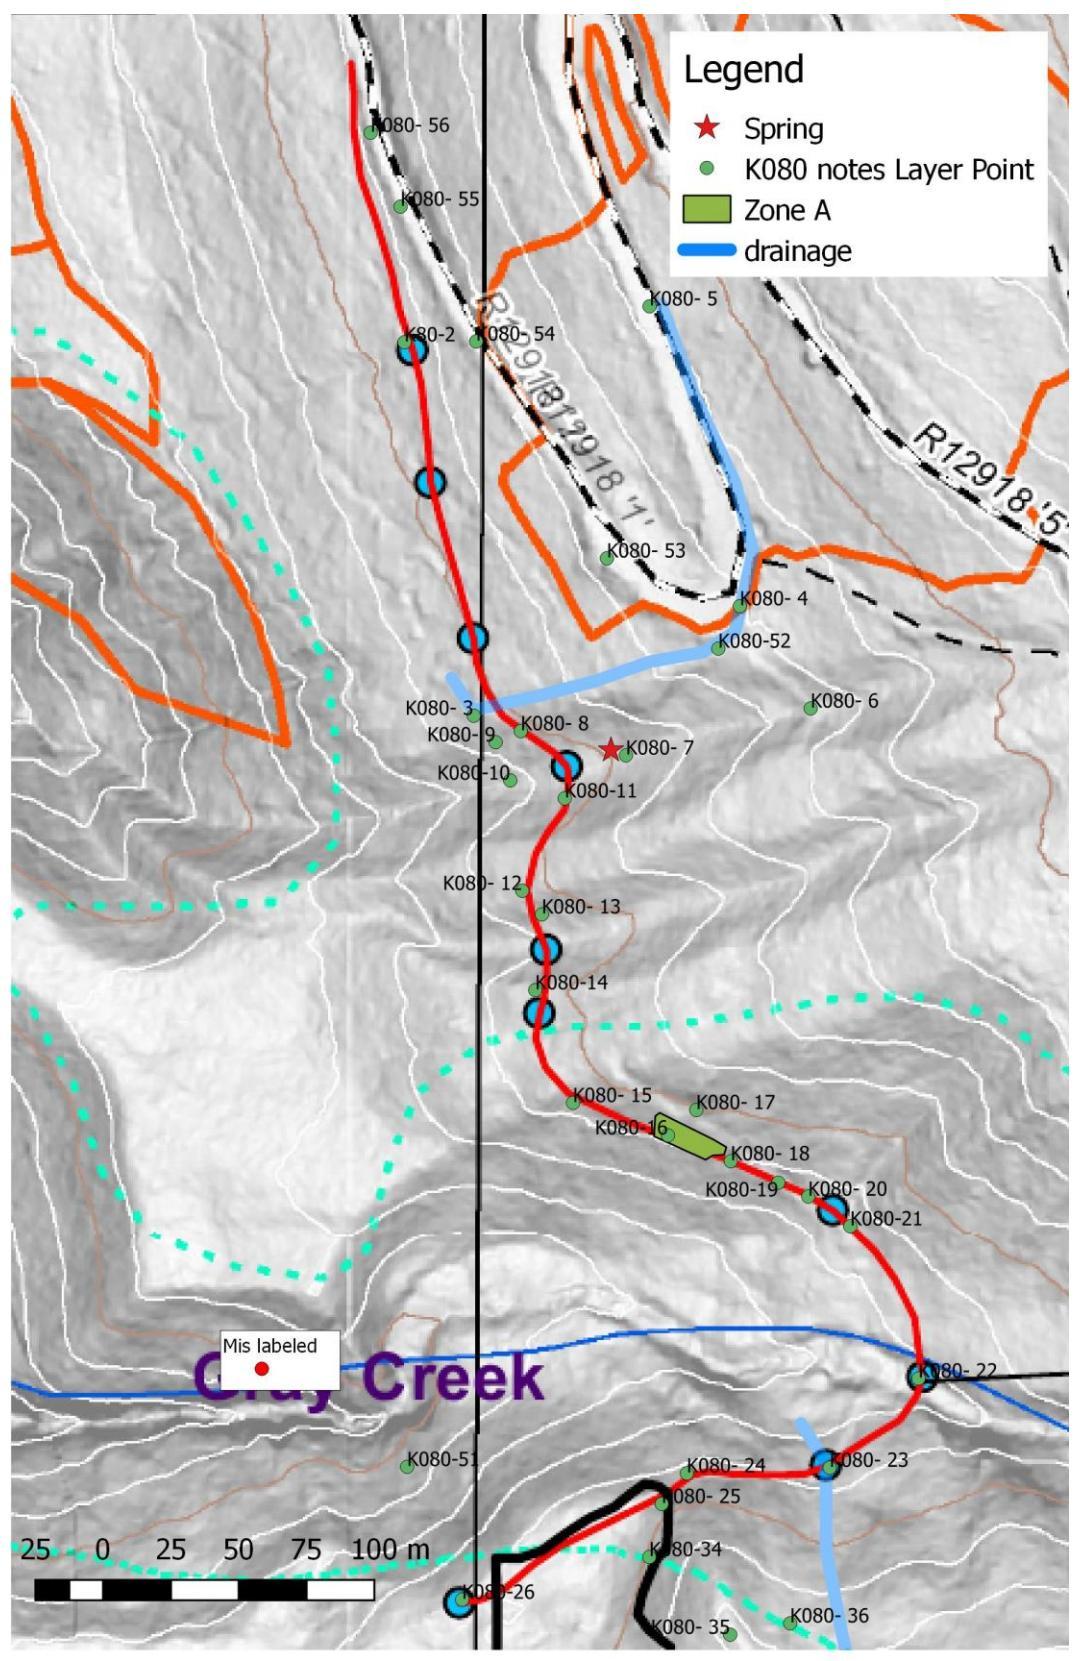
At the POC, the existing road (R12918 '1') is excavated into sub-vertically foliated Schist overlain by about 1m of silt (25%) sand (15%) gravel (60%). From the POC off the existing Forest Service road to K080 -03 the proposed road crosses a 35 to 45% gradient slope underlain by silty gravel, likely close to rock. At station K80 -03 there is an eroded channel (0.25m deep, 15m wide) on an old trail that heads up along the edge of the north gully. Water is intercepted and diverted along the existing upslope road (R12918 '1'), from about K080-05 and is directed around the switch at K080-04 onto the old trail, water can be safely directed off the trail at station K080-52 (marked with a small rock cairn).

From K080-03 to K080-14 the proposed road crosses two ancient debris flow/slide gullies (North Gully and South Gully). Neither gully has an obvious watercourse, although there is a spring in the North Gully just above the proposed road crossing (station K080-07). The northern sideslope of the north gully is underlain by sub-angular

gravel (shallow to rock) with a slope gradient of up to 65%, the south sideslope has a slope gradient of 55% and is underlain by moderately compact silty sandy gravel.

The South Gully (K080-12 to 14) has an ~ 6m 65 to 75% drop at the bottom (rock), the remainder of the slope is 55% and underlain by loose sandy gravel. There is no evidence of instability.

The road then goes onto a 35% gradient slope before heading onto McFarlane Creek gully sideslope (65 to 75% gradient). The slope is underlain by silty sandy gravel along the upper sections to boulder gravel along the lower section. An old road cuts across this slope. The old road has no drainage control, an oversteep cutslope and an oversteep fillslope which contains organic debris. The cutslope of the old road has sloughed to 75% with a 1-2m sub vertical cut at the top. There are small fillslope failures (Zone A figure #2) along a portion of this road, the failures did not progress to debris slides.

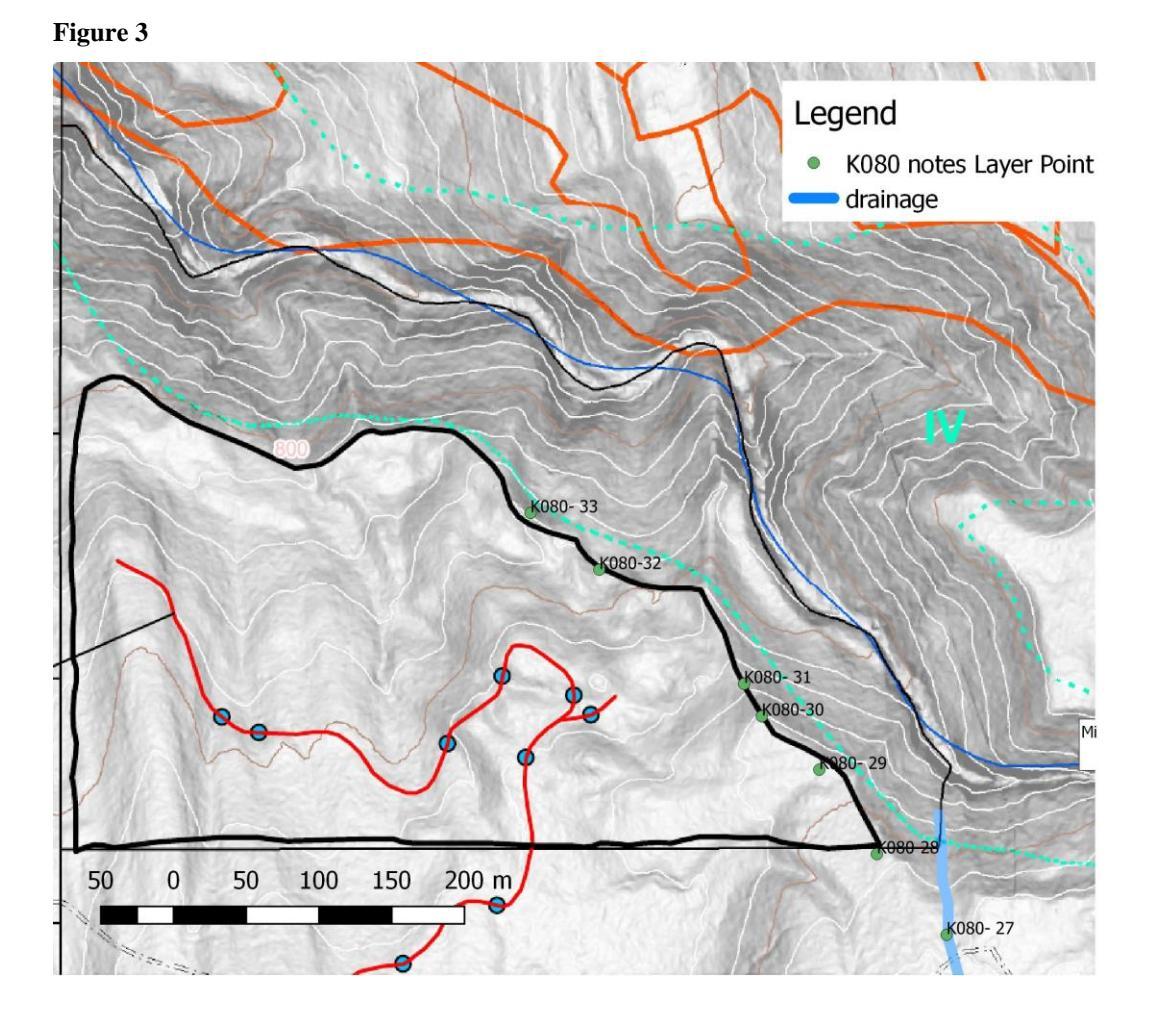
#### 4.2.1 Western Block (Figure #3)

Stations K080-28 to K080-33 are along the northern boundary of the western block, most of the boundary is along a ridge that separates the block from the sideslope to the creek. The terrain is hummocky loose sandy gravel, there appear to be large ancient slumps along the slope break. There is little direct connectivity between the block and the slope to the creek.

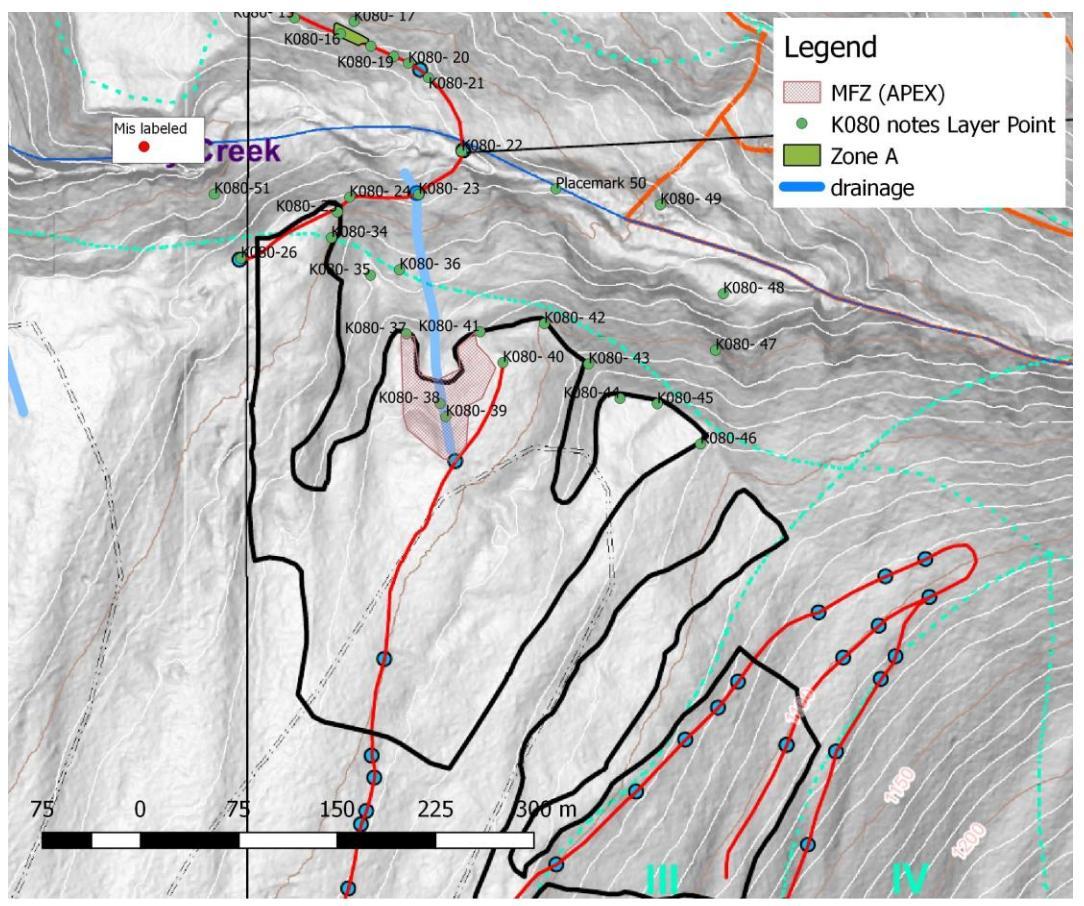
Stations K080-34 to 46 is along the northern edge of the eastern block. Like the western block the terrain is typified by ridges and hummocks of sandy gravel. It is likely that in places this material only thinly caps rock. At stations K080-37, and 39 there are pools of water, station K080 – 38 is in a broad wet area. This wet area is likely that result of an impermeable layer close to surface (the layer is likely rock). Station K080-47 (below the block) is on a steep rock slope, station K080-48 is on a large rubble rock fall cone, the stream has cut down through it, with a 500 to 1000-year-old smaller cone on top.

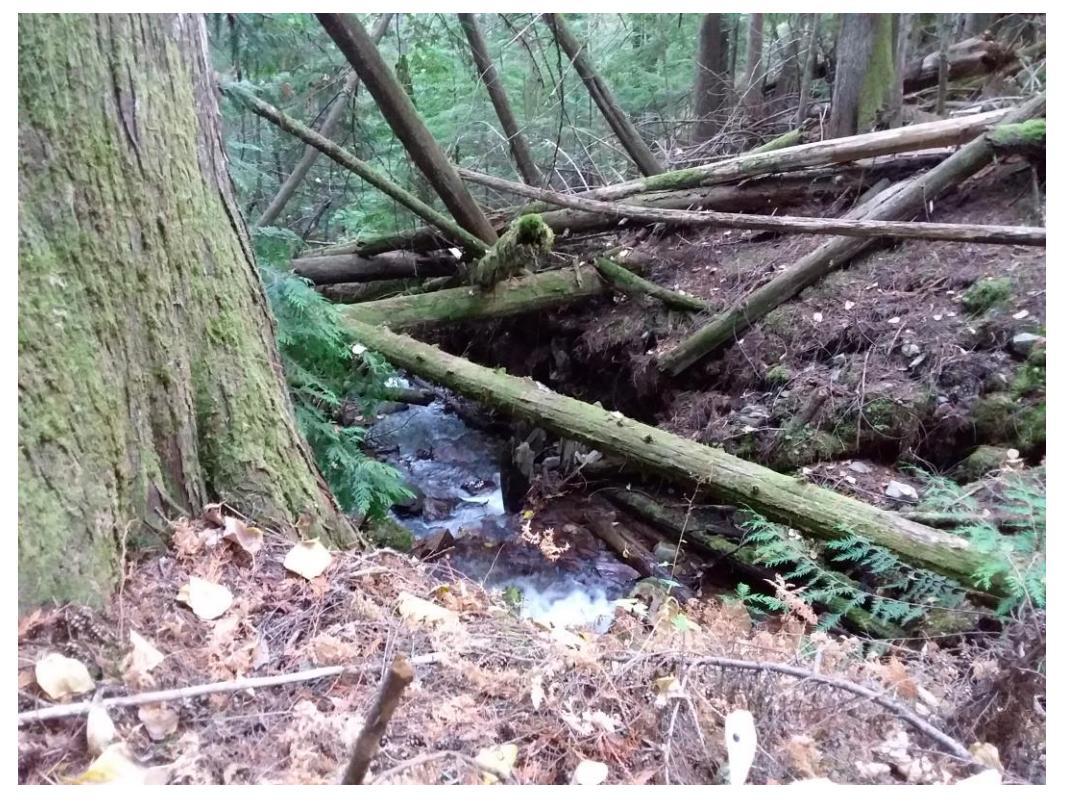
At stations K080-49 and Placemark 50 there are slides into the creek, likely the result of the stream undercutting the slope during a high flood event. The debris from both slides spanned the stream channel, erosion on the higher flats indicates the stream was ponded behind the debris deposit, then diverted around onto the valley flat, eventually the stream eroded through the debris dams. There is no evidence of dam burst flood events or debris flow/flood downstream of the debris deposits. The slide at K080-49 appears to be 25 to 50 years old, at station K080-50 the slide deposit has 30 cm diameter cedar on it and is possibly 75 to 100 years old. The debris deposits are for the most part still present, indicating mobilisation of large debris deposits is rare in this stream. The photo below shows the stream eroded through the debris pile station Placemark 50.

Photo 1 Eroded Slide Debris at Placemark 50 (note the difference in tree diameter of the tree in foreground and trees on debris).

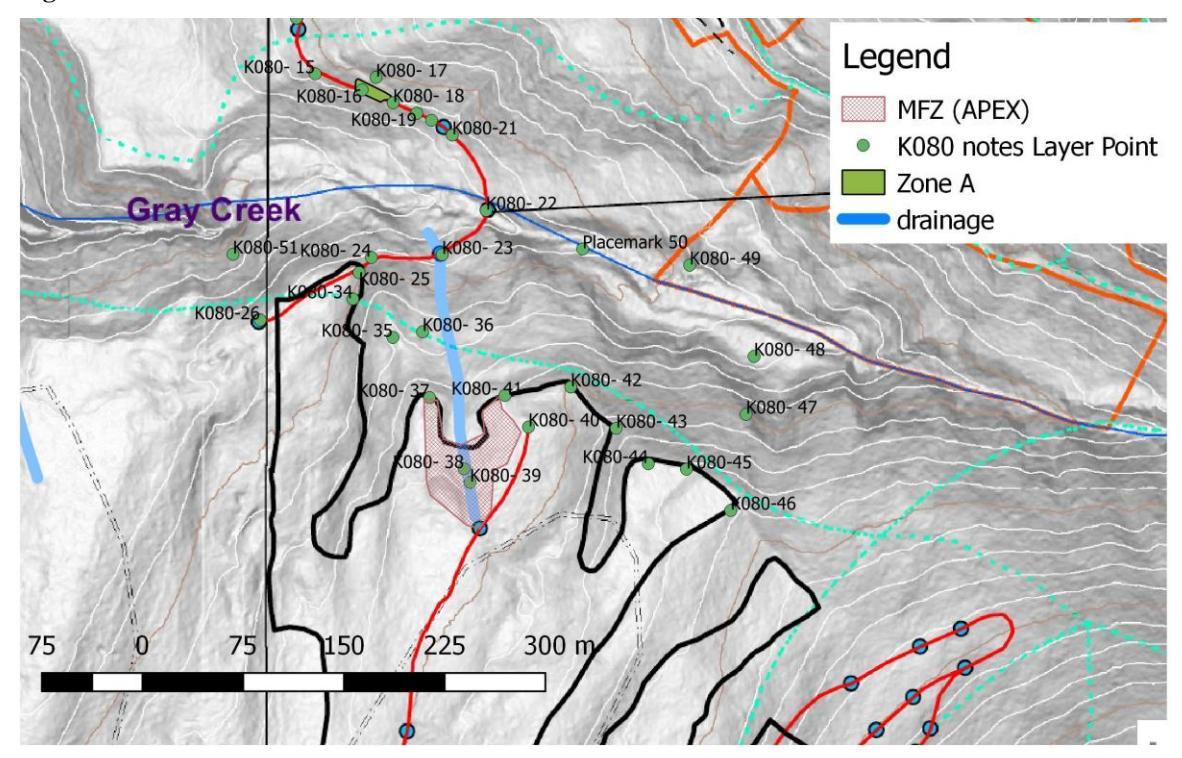
Figure 5

The "wet land" at stations K080-38 to 40 is likely the source of the stream at station K808-23. To avoid rutting and disrupting the drainage patterns this area should either be harvesting on snow/frozen conditions, low ground pressure machinery or delineated as a no machine zone (marked on figure 5).
