ROVER CREEK WATERSHED ASSESSMENT (2021)

Prepared for:
Troy Van Skiver, RPF
Kalesnikoff Lumber Co. Ltd
Thrums, BC

Prepared by:
Kim Green, P.Geo, PhD.,
Apex Geoscience Consultants Ltd
Nelson, BC

July 5, 2021

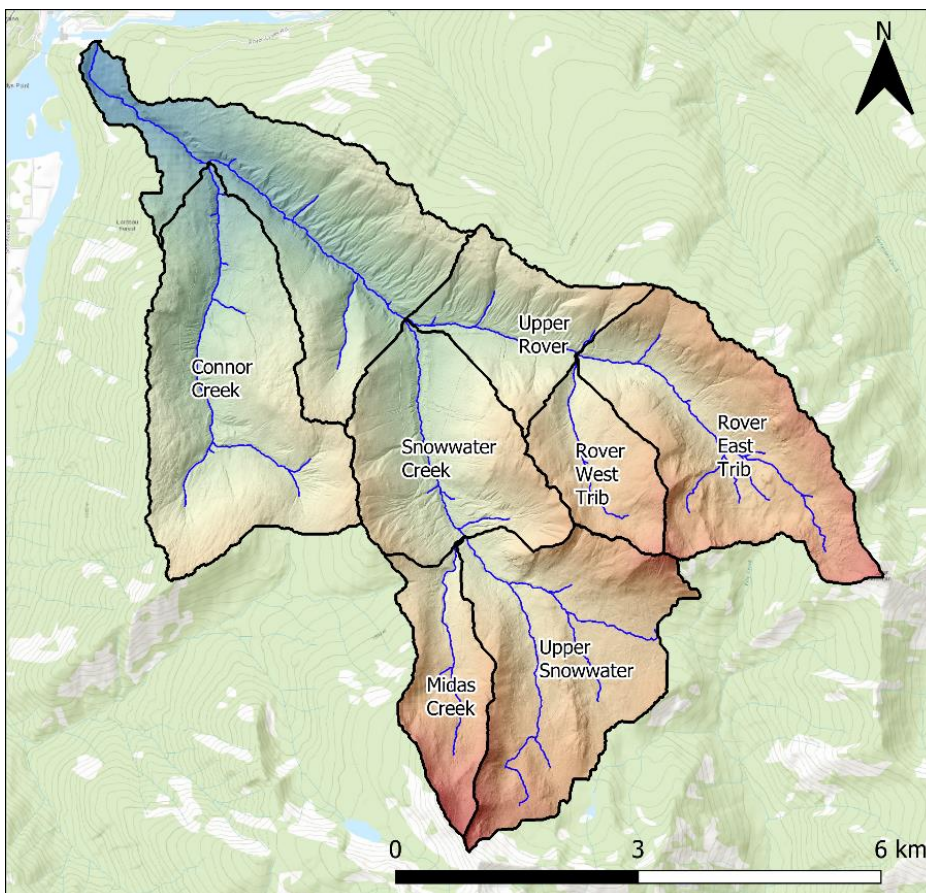
FIGURE 1. WATERSHED AND BASIN NAMES FOR ROVER CREEK USED IN THIS ASSESSMENT.

Rover Creek is a 4333-hectare watershed that ranges in elevation from 2244m at Mt. Conner to 526m at the confluence with Kootenay River. Rover Creek includes Connor Creek and Snowwater Creek tributaries. For this assessment Rover above Snowwater Creek is identified as Upper Rover.

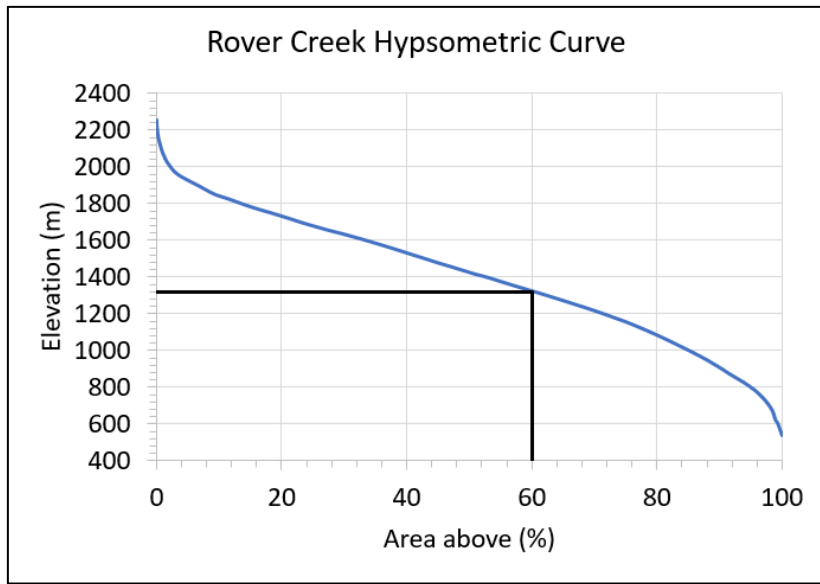
The watershed is characterized by a large component of high elevation slopes. A hypsometric curve of Rover

Creek indicates the H60 elevation is at 1320 meters while the H20 elevation is just over 1720 meters.

FIGURE 2. HYPSONETRIC CURVE FOR ROVER CREEK INDICATES A LARGE COMPONENT OF HIGH ELEVATION SLOPES. THE H60 ELEVATION IS AT 1320 METERS.

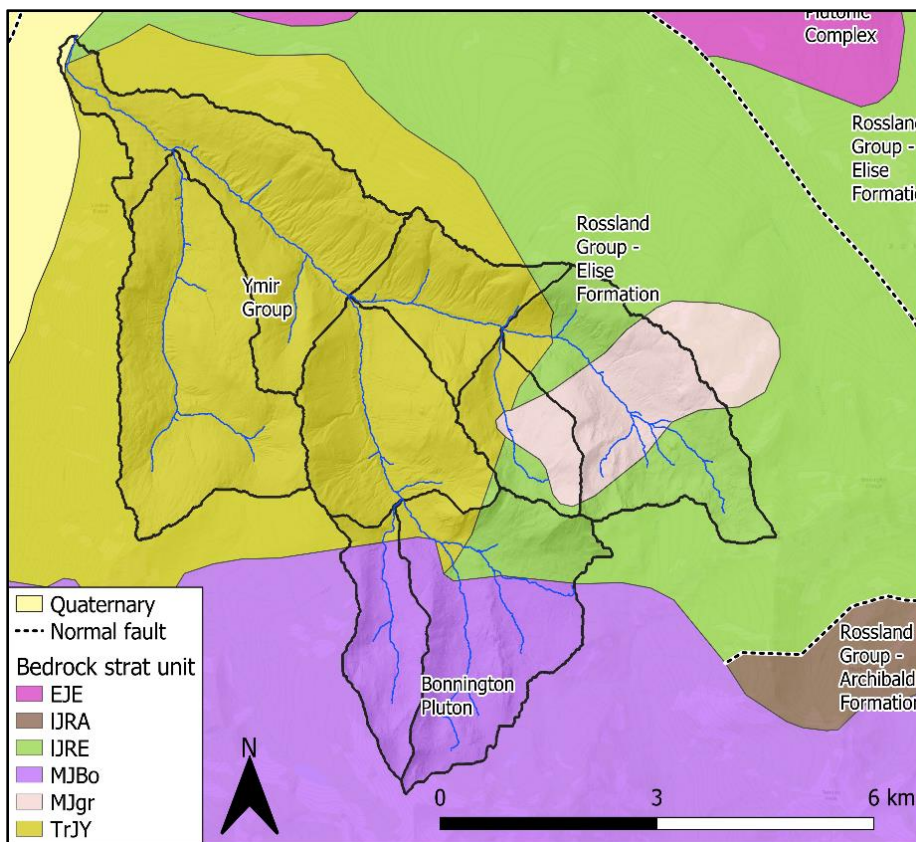
Rover Creek is underlain by a variety of bedrock lithologies. The lower elevations are underlain by fine grained metamorphic sedimentary and volcanic tuffaceous rocks of the Ymir Group while upper elevations of Rover Creek are underlain by mafic volcanic and intrusive rocks of the Rossland Group. Coarsely crystalline granodiorites of the Bonnington Pluton underly upper Snowwater and Midas Creeks (Figure 3)

FIGURE 3. GEOLOGY OF THE ROVER CREEK AREA (IMAPBC)

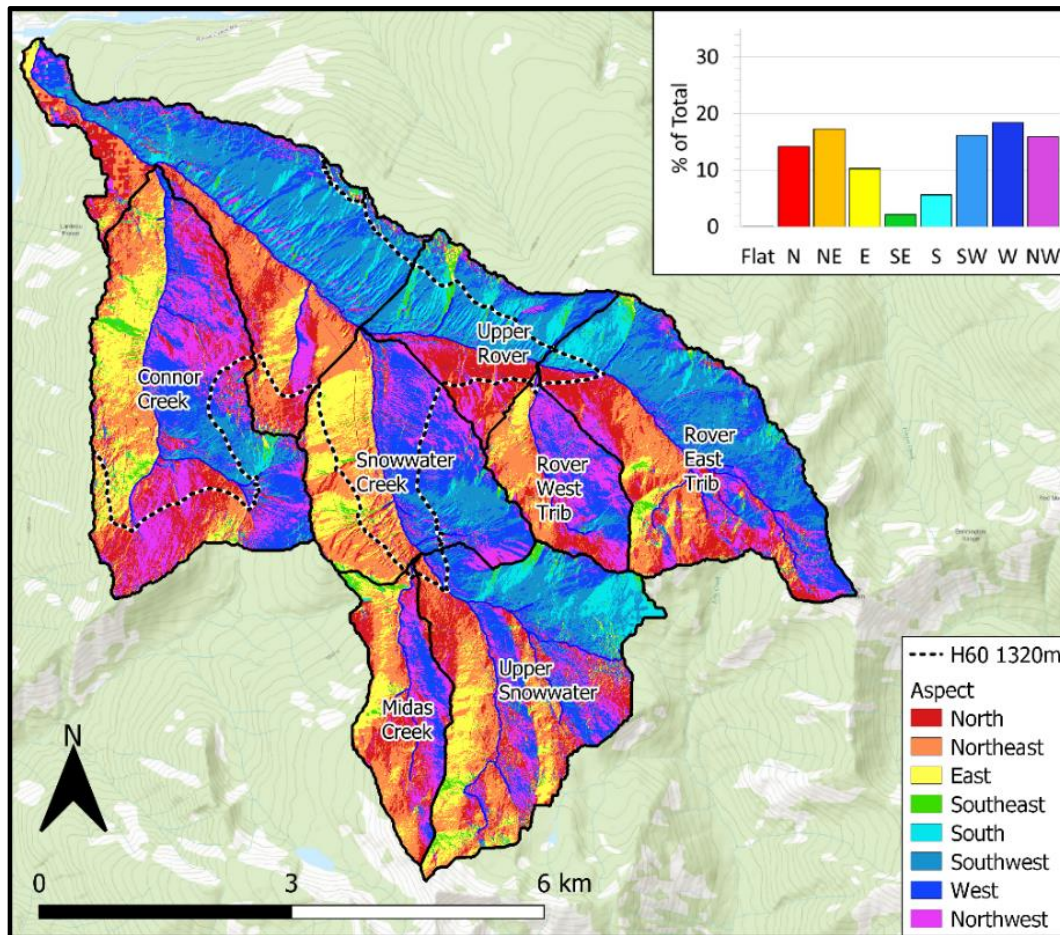
FIGURE 4. ASPECT DISTRIBUTION IN ROVER CREEK WITH THE H60 LINE.

The histogram of aspect distribution in Rover Creek (Figure 4) shows that slopes are southwest/west/northwest (shades of blue) and north/northeast/east (red, orange, yellow). Contrasting aspects result in differences in snowmelt timing from openings and juvenile stands situated across this range in aspects. Stands in Snowwater Creek that were monitored during the 2020 snowmelt period confirm that the southeast aspect open stand at 1500-meter elevation was snow free a full two weeks before the north aspect open stand at the same elevation. The contrasting aspects in Rover Creek are likely reducing the cumulative hydrological effects from the current level of disturbance.

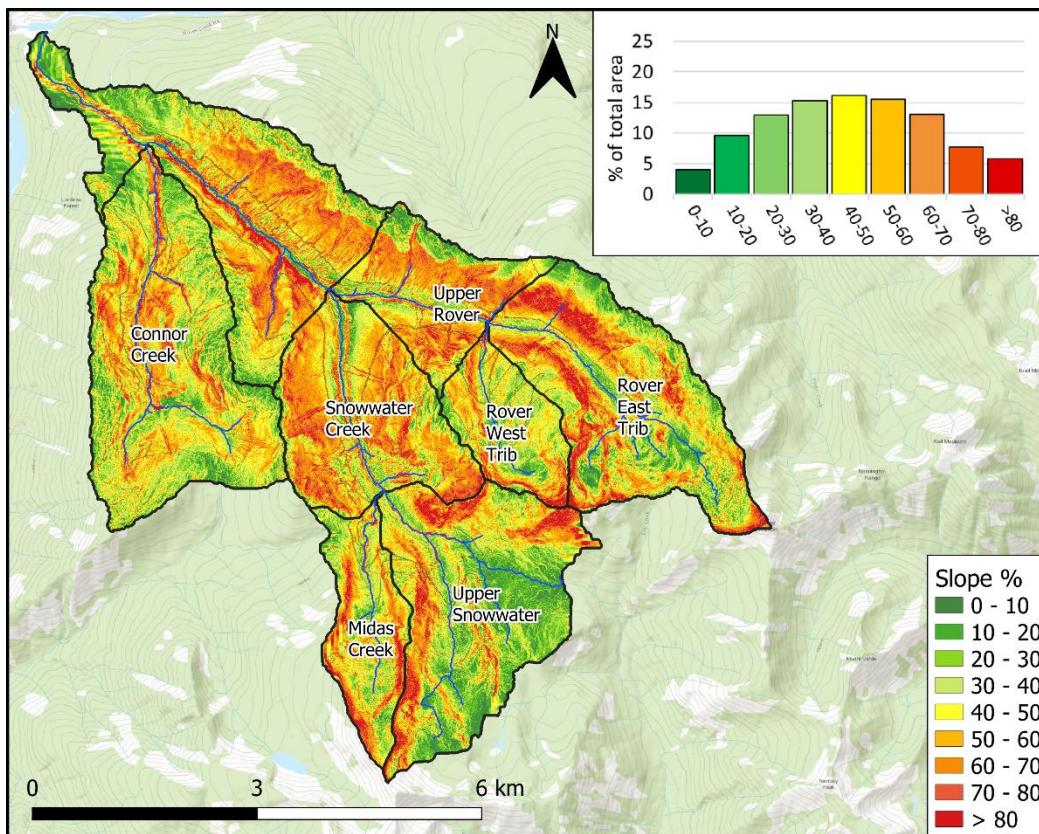
Much of Rover Creek is classified as moderate to steep gradient with slope gradients exceeding 40%. The steepest gradient slopes occur on the valley sides along the main channels. The heights of land along ridgelines are generally gentler gradients leading to the occurrence of gentle-over-steep terrain in many parts of the watershed.

FIGURE 5.
DISTRIBUTION OF
SLOPE GRADIENT IN
ROVER CREEK

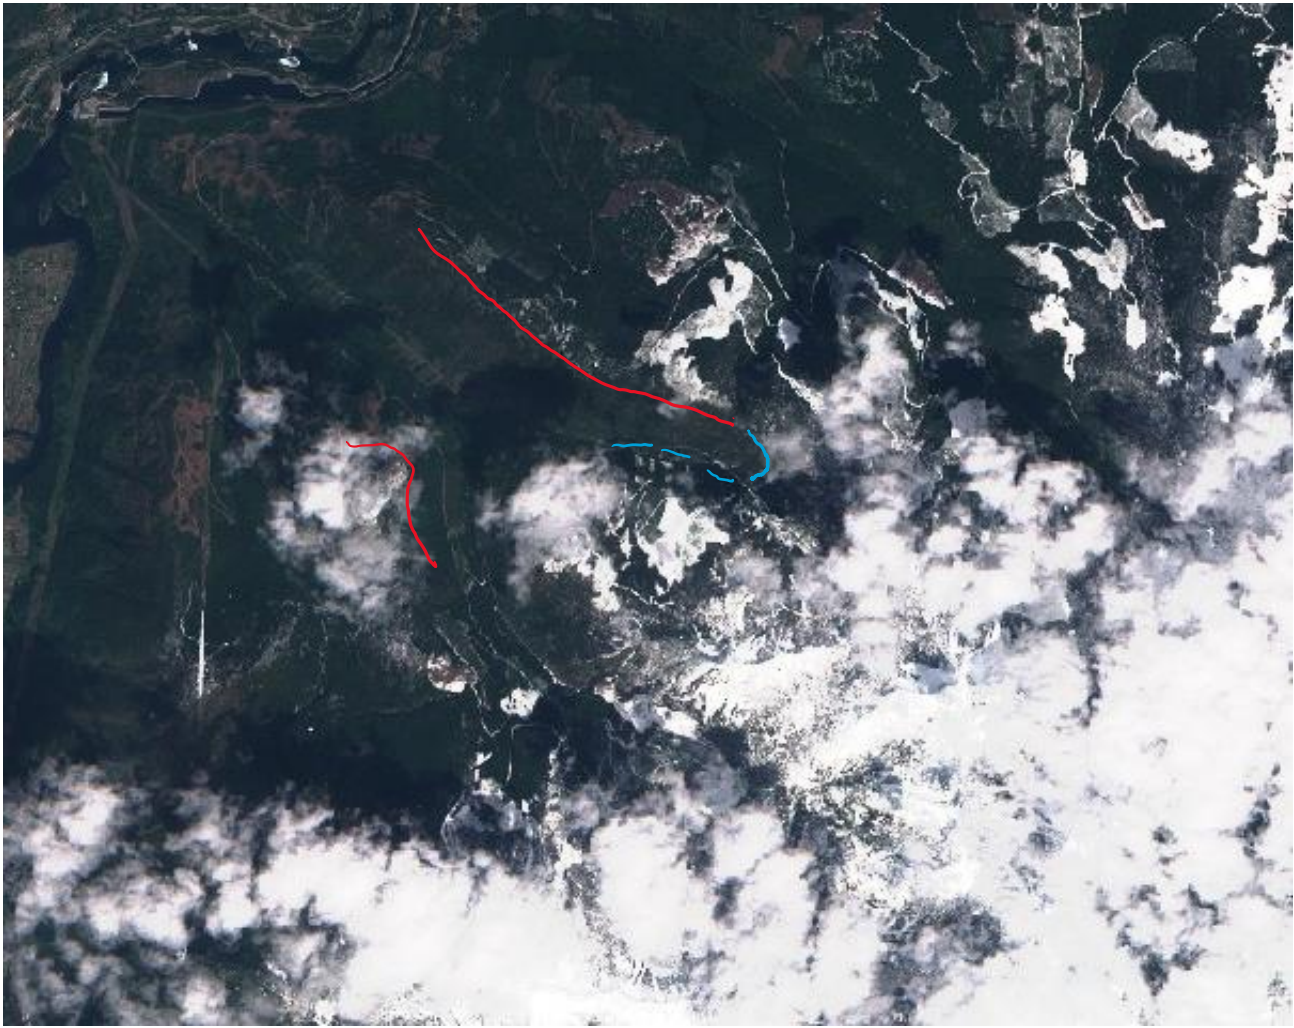
Discharge gauging on Rover Creek (Selkirk College study) indicates that an initial solar-radiation driven peak occurred between May 19th and May 21st 2020 followed by a large, rain-on-snow debris flood event on May 31st. A sentinel satellite photograph taken during early May (May 9, 2020, Figure 6) shows that the slopes below about 1350 meters on west, southwest and east slopes were snow free (red line) while snow was still present on north aspect slopes below about 1200 meters elevation (blue dashed line). The difference in snowmelt timing across aspects highlights that the H60 line in Rover Creek is only a rough estimate of the 'snow sensitive' zone in this watershed. In addition to delayed snowmelt on north aspect slopes, tight valleys in upper Snowwater, Midas and Upper Rover tributaries function to retain snow due to the influence of shading throughout the day in these areas.

FIGURE 6. SENTINEL SATELLITE IMAGE FROM MAY 9TH 2020 IN ROVER CREEK. RED LINE CORRESPONDS TO APPROXIMATELY 1350 METERS WHILE BLUE LINE CORRESPONDS TO ABOUT 1150 METERS ON THE NORTH ASPECT SLOPES.

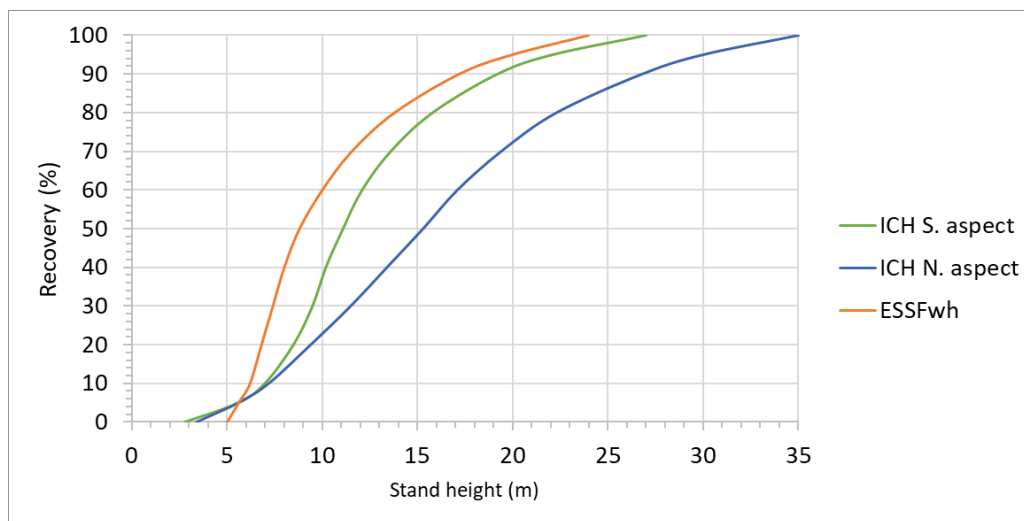
The Rover Creek-based recovery curves are provided in Figure 7. These curves differ to some degree from the recovery curve produced by Winkler and Boon (2015) for Thomspen-Okanagan spruce – pine stands. In Rover Creek a stand located on north aspects in the ICH biogeoclimatic (BEC) zone is considered fully mature when it has a height of 27 meters and a LiDAR-derived canopy cover of 75% or greater while a stand located on south aspects in the ICH BEC zone in Rover is considered fully mature when it has reached a height of at least 22 meters and has a LiDAR-derived canopy cover of 55% or greater. A stand located in the ESSFwh BEC subzone is considered fully mature when it has reached a height of at least 20 meters and has a canopy cover of at least 45%. Locally, mature stands in the ESSFwm subzone in Rover creek are similar in height and canopy cover to mature stands in the ESSFwh subzone. Disturbed stands in the ESSFwm subzone in Rover Creek are located immediately adjacent to the ESSFwh subzone and are assigned recovery values based on mature stand characteristics in the ESSFwh subzone.

FIGURE 7
PRELIMINARY
HYDROLOGICAL
RECOVERY CURVES
DEVELOPED FROM
SNOW SURVEY DATA
FROM SELKIRK
COLLEGE STUDY.

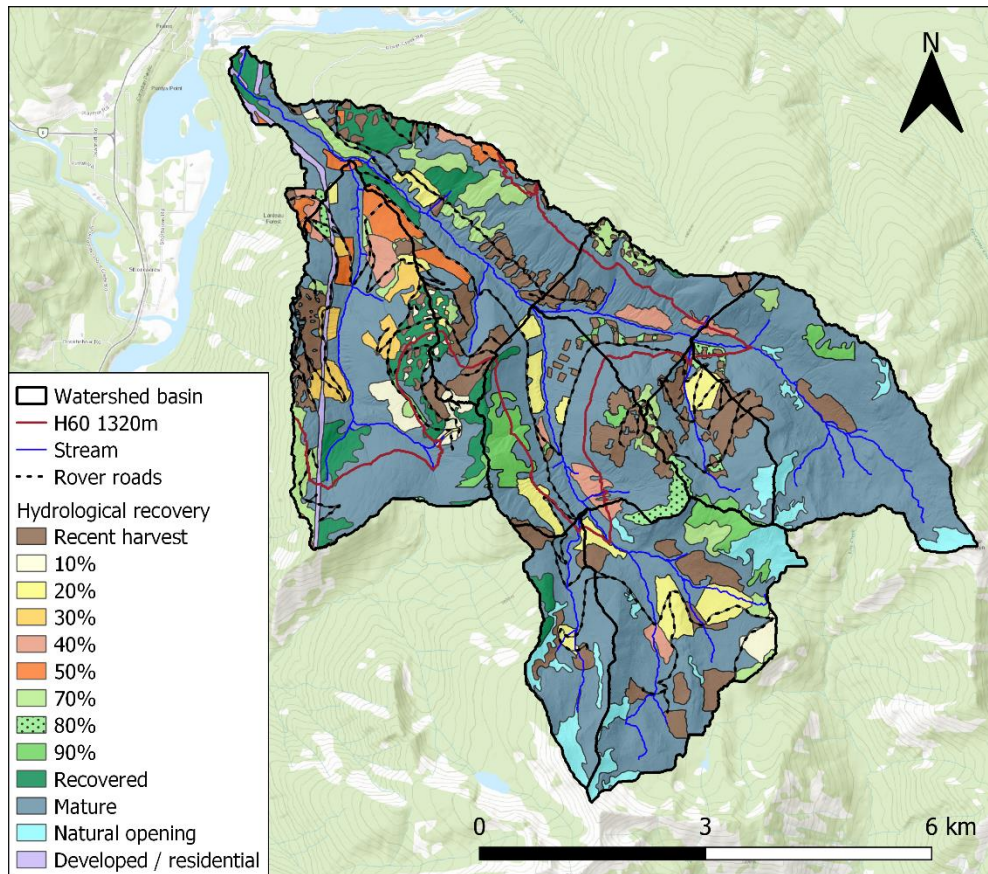
Currently 1160 hectares or 27% of the 4333-hectare Rover Creek catchment is considered in a disturbed condition. When hydrological recovery is applied the current ECA for the watershed is estimated at 964 hectares or just under 23% of the total watershed area (Figure 7 and Table 2). The ECA above the H60 elevation of 1320 meters is estimated at 510 ha or about 12% of the watershed area.

FIGURE 8. CURRENT ESTIMATED HYDROLOGICAL RECOVERY (%) OF CUT BLOCKS IN ROVER CREEK. THE H60 ELEVATION (1320M) IS SHOWN IN RED.

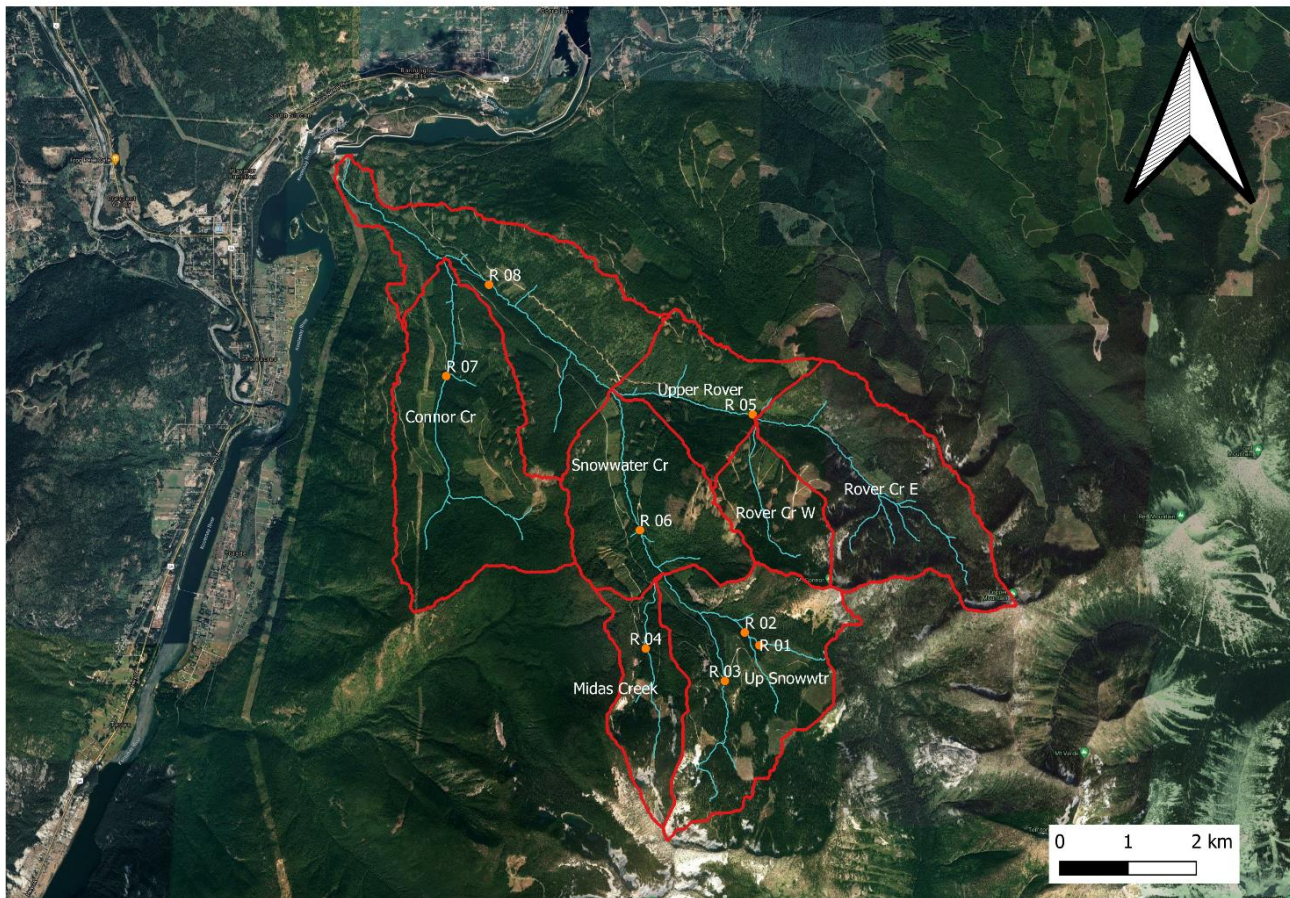
Road access allowed investigation of the channel of Rover Creek in several locations along its length from the upper headwaters of Snowwater and Upper Rover creeks to the reach of Rover Creek above the FSR 4 Km bridge (Figure 9). The channel was assessed in October 2020 during low flow conditions. Information on channel morphology, mobile bedload, riparian function, and historical disturbance events were noted during the field survey. Measurements of channel geometry and maximum mobile grainsize were collected at each of the field sites and is used to calculate bankfull flow and stream power to provide an understanding of the processes of sediment and water movement through the watershed. Figure 9 shows the location of the field sites from the 2020 field surveys.

FIGURE 9. LOCATION OF FIELD SITES IN ROVER CREEK

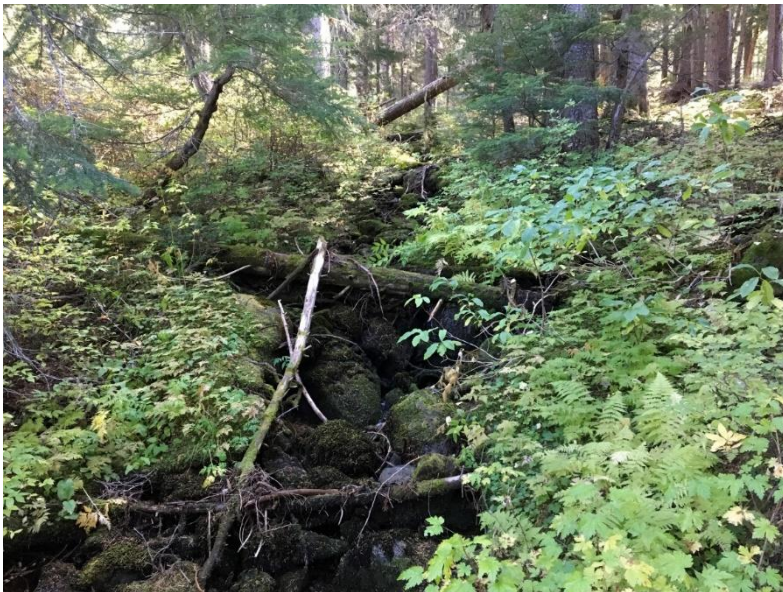
The channel of Snowwater Creek was investigated at several sites from its headwaters to the reach above the confluence with Rover Creek (Figure 9). In the eastern headwaters (site R01), the channel has a gradient of 10% and is a mossy, angular boulder cascade colluvial channel with no indications of mobile sediment larger than gravel (<3cm). Some of the small woody debris (small branches and needles) was mobile this past freshet but woody debris larger than about 10 cm diameter has never moved (>200 yrs) and there are no

indicators of larger flood events such as debris levees along this reach of the headwater channel. Riparian vegetation is hemlock, spruce and balsam up to 70cm diameter.

PHOTO 1. LOOKING UPSTREAM ON UPPER SNOWWATER CREEK AT SITE R01

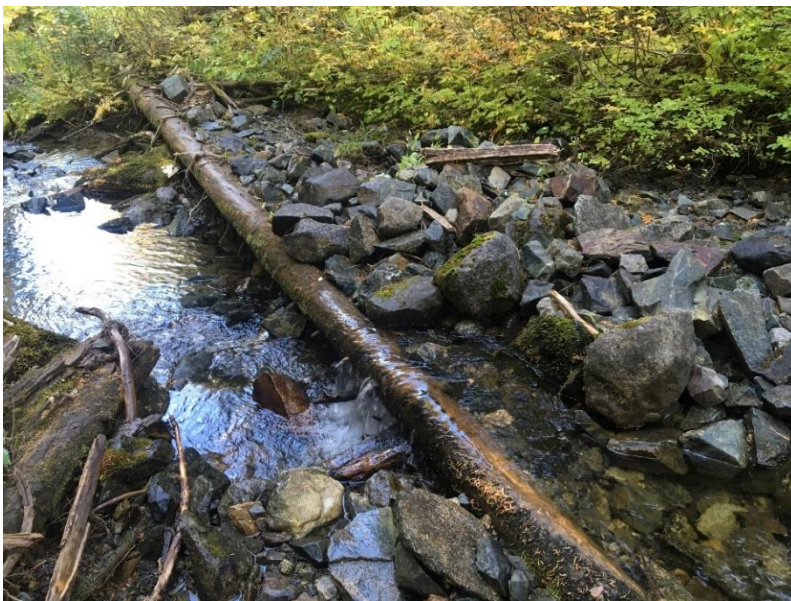
However, evidence of recent channel disturbance related to this past year's flood was noted at site R02 (Photo 2). Here, the channel has a forced step morphology with a gradient of 7%, a bankfull width of 4m and angular cobbles to about 18 cm were mobile during the 2020 freshet. Large woody debris is present in the stream but was mobilized in the 2020 flood. Some fresh bank scour is also present but otherwise banks are overhanging and vegetated with herbaceous plants, moss and

PHOTO 2. LOOKING DOWNSTREAM AT SITE R02 ON UPPER SNOWWATER CREEK

Before this recent disturbance, the last channel forming flood causing channel avulsion and movement of large woody debris appears to be over 100 years old based the degree of decomposition of wood and age of riparian vegetation which includes mature hemlock and fir over 50 cm in diameter. The 2020 flood caused some of the older woody debris to break apart.

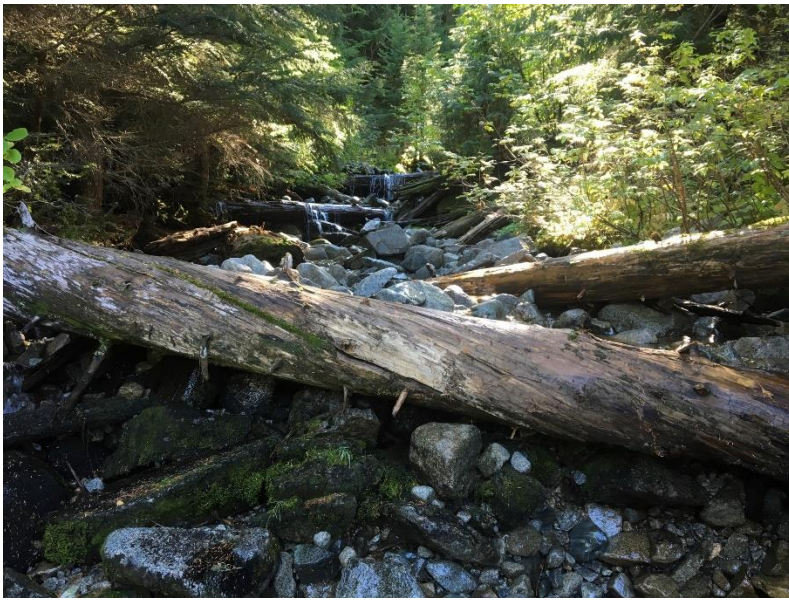
The western headwater of Snowwater Creek observed at site R03 has a notably different appearance than the eastern tributary observed at sites R01 and R02. In this reach the riparian vegetation has been logged and consists of smaller (to 40cm max) cedar and hemlock with small saplings less than 10cm along the channel banks. Old cut logs are in the channel and some are creating steps that are functioning to retain cobbles.

PHOTO 3. LOOKING UPSTREAM ON THE WESTERN TRIBUTARY OF UPPER SNOWWATER CREEK AT SITE R03.

The coarse cobble to boulder bedload in the channel appears bright and very mobile with little moss. Subangular boulders up to 35 cm were mobilized in the 2020 freshet. Here the boulders are primarily granitic in composition in contrast to metasediments and volcanic rocks in the eastern tributary. Some of the older woody debris in the channel appears to have entered after a burn. Channel banks are eroded and

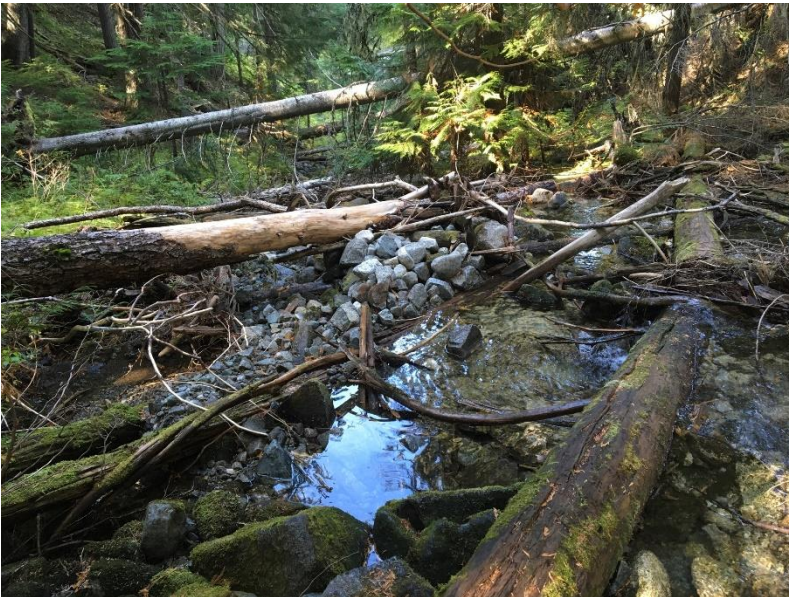
PHOTO 4. LOOKING DOWNSTREAM AT MIDAS CREEK BELOW FSR

The channel of Midas Creek is a mossy, blocky colluvial channel with a gradient of 20% above the Rover FSR and a bankfull width of 2.3 meters. There is very old, large woody debris in the channel that has not recently moved although some movement of small woody debris (branches) is evident and cobbles up to about 20 cm were moved in the 2020 freshet.

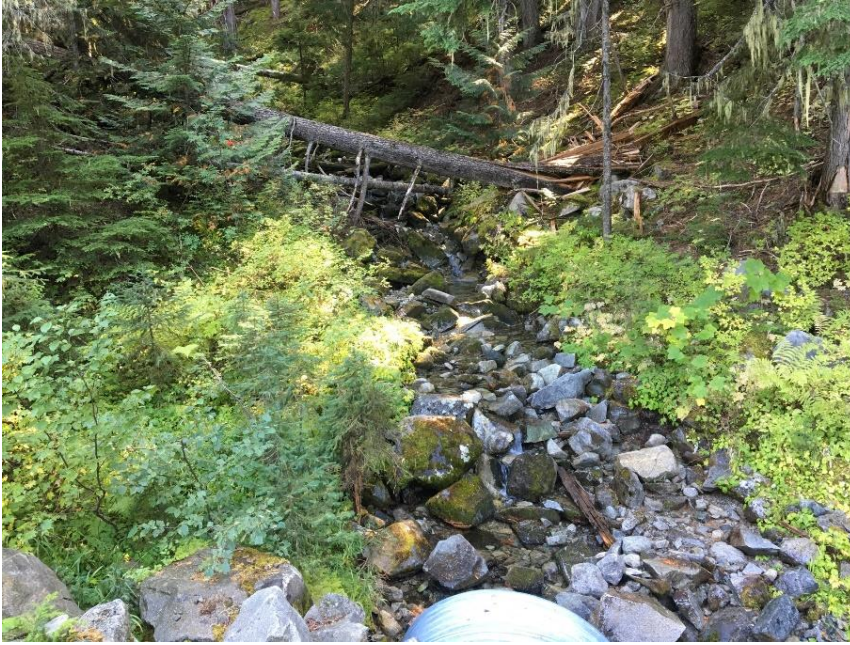
Channel banks are overhanging and vegetated and the riparian vegetation consists of mature cedar, spruce, balsam fir and hemlock. Some gravel deposits from a past 10 to 20 year old flood event are evident but most of the lateral sediment deposits are mossy.

PHOTO 5. LOOKING UPSTREAM ON MIDAS CREEK AT FSR.

The vegetated lateral flood deposits can be seen on the right side of the channel of Midas Creek in photo 5.

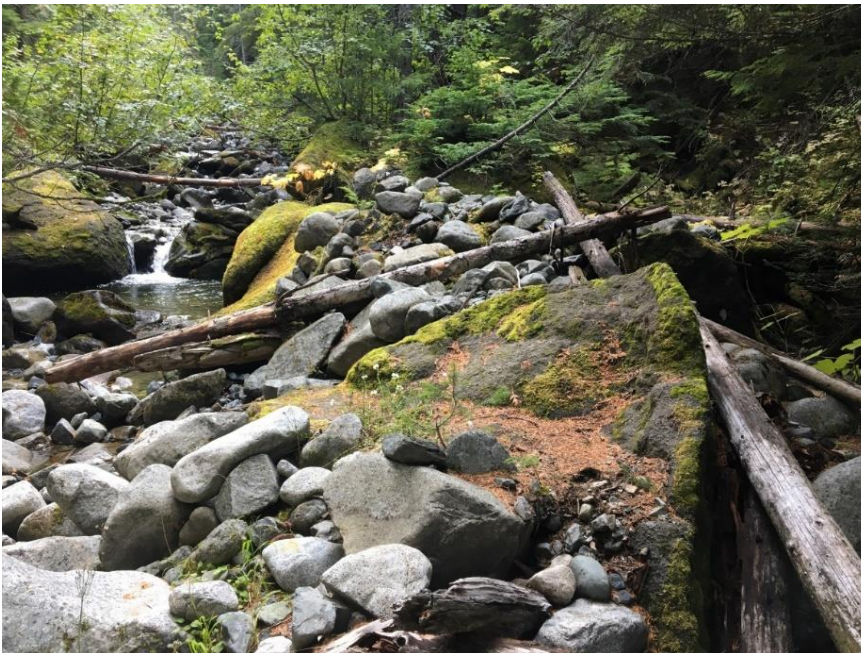
PHOTO 6. LOOKING UPSTREAM AT SITE R06 ON SNOWWATER CREEK ABOVE ROVER CREEK

Snowwater Creek at site R06 above the bridge has a cascade- boulder morphology with a gradient of 13% and a bankfull width averaging 5.4 meters. The granitic/gabbroic cobbles and boulders in the channel are generally bright, imbricated and subrounded suggesting they are moving during infrequent large flood events. Boulders larger than about 60cm are mossy suggesting they have not moved for several decades. Cobbles to about 16cm appear to be mobile annually but boulders up to 40 cm were mobile in 2020 flood.

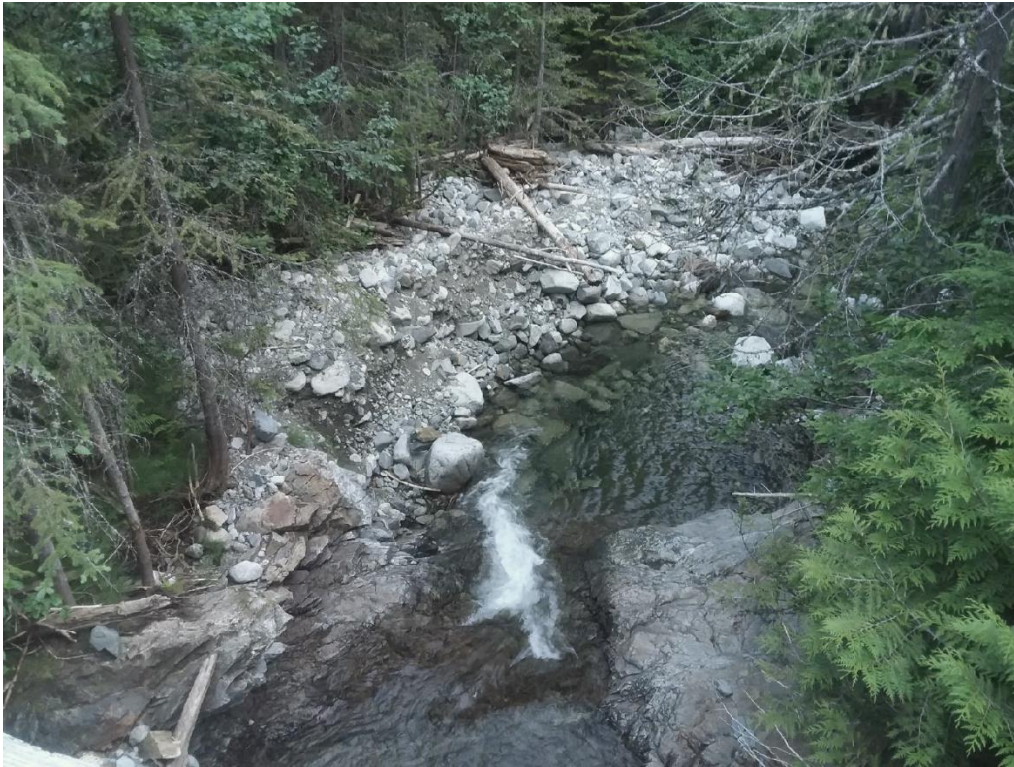
Below the Snowwater Creek bridge the channel immediately downstream hosted a debris flood during the 2020 flood and all bedload including the largest boulders were mobilized (Photo 7). It appears that the slight

constriction of the channel at the bridge caused flow velocity to increase enough to initiate a debris flood. It is not known how far downstream this debris flood continued but it is likely the turbidity from this event was carried down to the lower reaches of Rover Creek.

PHOTO 7. LOOKING DOWNSTREAM FROM BRIDGE OVER SNOWWATER CREEK AT SITE R-06. THE CHANNEL OF SNOWWATER CREEK HOSTED A DEBRIS FLOOD ALONG THIS PORTION OF THE CHANNEL IN 2020.

In addition to the recent debris flood deposit, a flood terrace containing broken LWD is present along the upper channel margins and appears several decades old (1974?).

Snowwater Creek below the Rover Creek FSR bridge hosted a debris flood in 2020 that likely mobilized a large volume of fine sediment. The debris flood appears to have been triggered by the constriction of the channel created by the bridge footings that increased flow velocity of the exceptionally high 2020 runoff on the downstream side sufficiently to initiate the debris flood. It is not known how far downstream this debris flood continued. The short-duration debris flood in the mainstem of Rover Creek that was observed in the vicinity of the 4km bridge on May 31, 2020 was the result of cumulative runoff from exceptionally high discharge related to the rain-on-snow and likely not directly related to the Snowwater Creek debris flood.

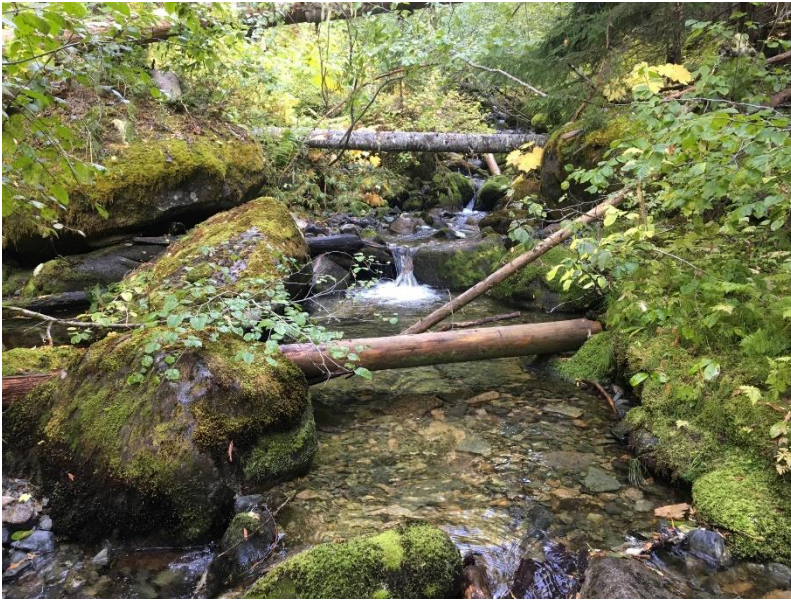
The lack of roads along upper Rover Creek limited access to this portion of the Rover Creek channel. The channel of upper Rover Creek was investigated at site R05 (Figure 9). At this site, the channel is substantially different from adjacent Snowwater Creek. It is smaller with a bankfull width of just over 4 meters and a gradient of over 15%. In addition, the channel is much darker and cobbles larger than about 30 cm are moss covered. The sediment bedload is generally finer textured with gravel and cobbles up to about 15 cm mobile annually.

There was recent bank scour/erosion related to the 2020 flood and some movement of LWD but no evidence of past large flood events. Some LWD is functioning in the channel but most is suspended above, and the large lag boulders present in this channel limits the ability of LWD to connect with the channel bed.

PHOTO 8. LOOKING UPSTREAM AT SITE R05 ON UPPER ROVER CREEK

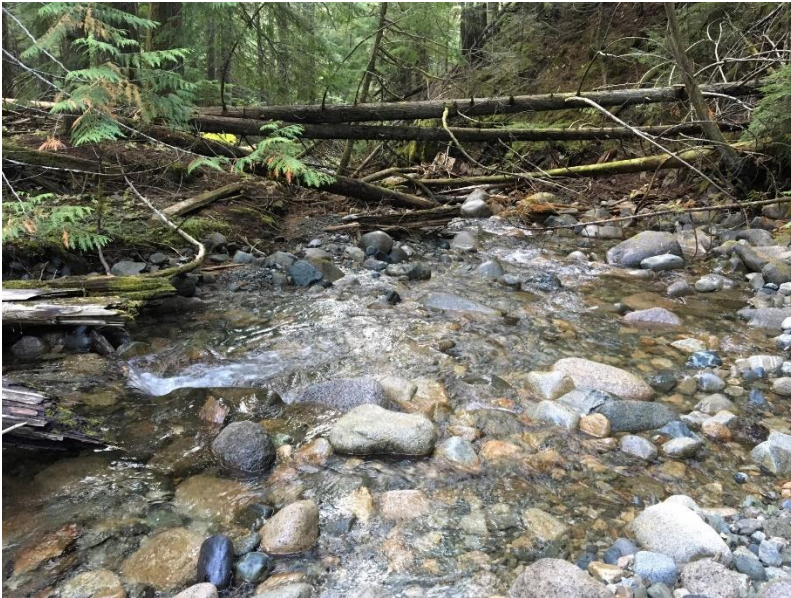
The channel of Rover Creek was investigated upstream of the FSR bridge at 4 km. The channel has a step pool to forced step pool morphology. Rounded cobbles to 20 cm are mobile annually but boulders up to 50 cm were mobile in the 2020 flood. These 50 cm boulders are also forming steps in the channel of Rover Creek. The channel bed is bright and appears to have been fully mobile in 2020. An old flood deposit estimated at approximately 40 yrs old (~1974) is evident as a boulder level with alders, saplings and suspended LWD along upper channel banks. Channel banks were eroded in the 2020 flood.

PHOTO 9. LOOKING DOWNSTREAM AT ROVER CREEK ABOVE THE 4KM FSR BRIDGE

The riparian vegetation in this area is mixed cedar and hemlock to 60 cm diameter. There is some broken old LWD along channel banks and newer woody debris suspended above the channel but most of the functioning LWD appears to have been flushed out of the channel during the flood event that occurred approximately 40 years ago (1974?).

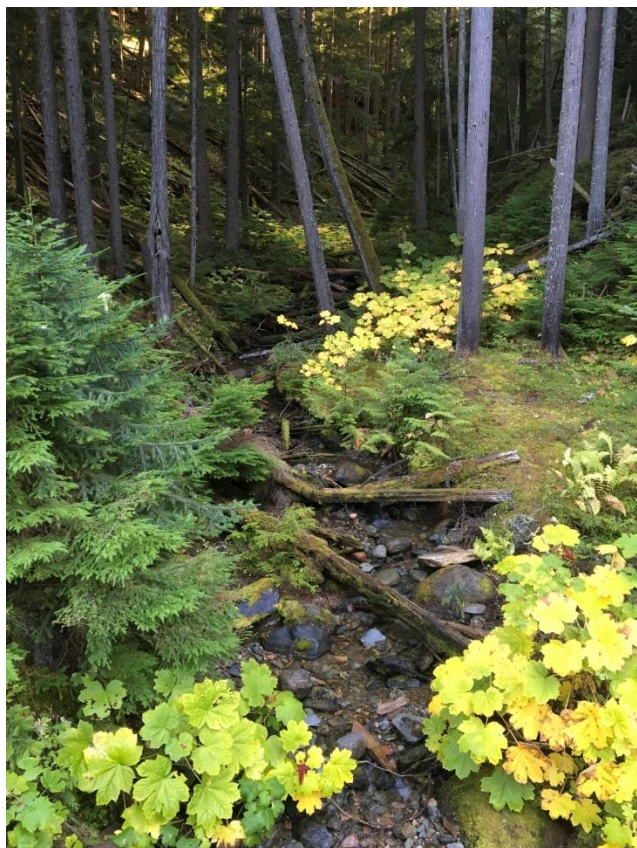
The channel of Connor Creek is very different in appearance from Snowwater or Rover Creek. Upstream from the Connor FSR it is small, with a bankfull width of just under 3 meters and a gradient of between 5 and 10 percent. Connor Creek has a forced woody debris step pool morphology and there is abundant, very old LWD

functioning in the channel creating sediment-retaining steps. Much of the woody debris appears to have been functioning in Connor Creek for over a century.

PHOTO 10. LOOKING UPSTREAM ON CONNOR CREEK ABOVE CONNOR FSR

Generally, the mobile bedload of Connor Creek is limited to small cobbles and gravel less than 8 cm but cobbles up to about 16 cm were mobile during the 2020 flood. Banks are vegetated and overhanging but some recent scour is present. The riparian vegetation includes hemlock to 60 cm diameter.

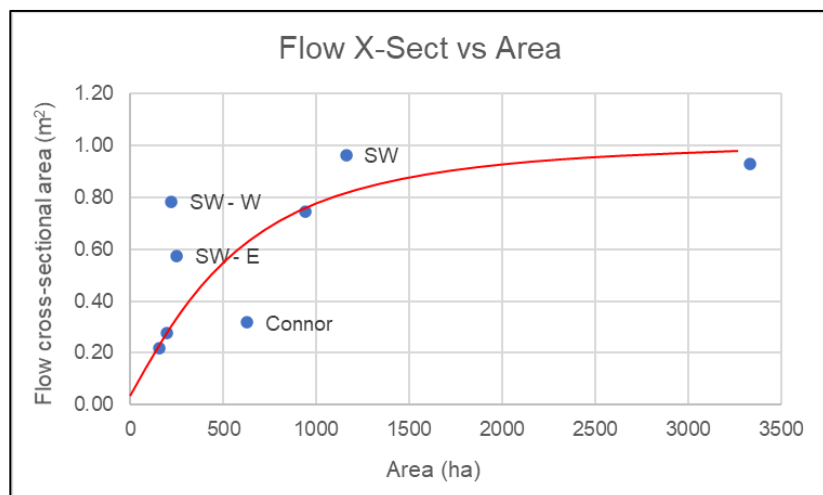
The relationship of flow cross-sectional area (bankfull width x average bankfull depth) to upstream watershed area (the area of the watershed draining to the survey site) provides information on the relative discharge from the various headwater basins in Rover Creek (Figure 10).

FIGURE 10. BANKFULL FLOW CROSS-SECTIONAL AREA TO WATERSHED AREA

The bankfull flow cross-sectional area of the Snowwater – West headwater channel (Site R03) is substantially larger in size than similar sized Snowwater East channel (R02). In addition, Snowwater Creek at site R06 (SW on Figure 10) sits above the overall trend of the graph. Conversely, Connor Creek lies below the trend for Rover Creek. This graph indicates

that during average runoff years, Snowwater Creek is providing proportionally, more of the peak runoff in Rover Creek.

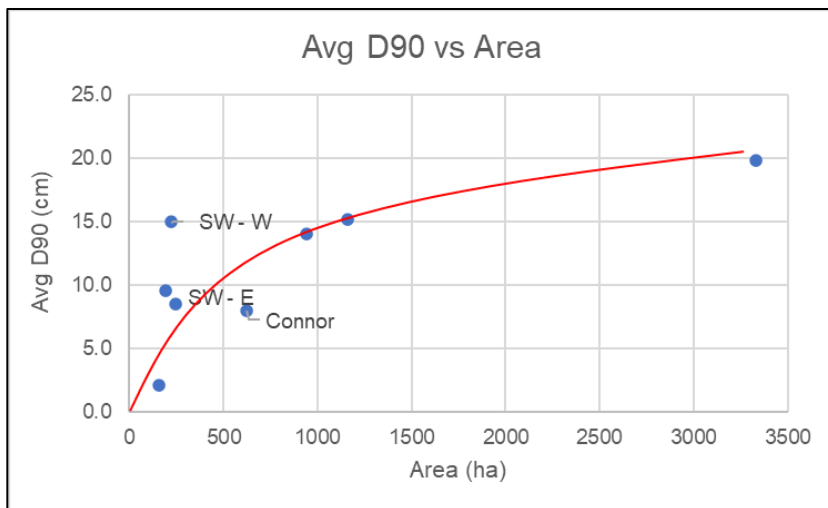
FIGURE 11. AVERAGE MAXIMUM MOBILE GRAINSIZE VERSUS WATERSHED AREA IN ROVER CREEK.

In addition to providing more of the annual peak flow the channel of Snowwater Creek (West) has a substantially larger mobile bedload than the general trend observed in Rover Creek (Figure 11). This graph also shows that the maximum mobile bedload in Connor Creek lies below the overall trend in Rover Creek.

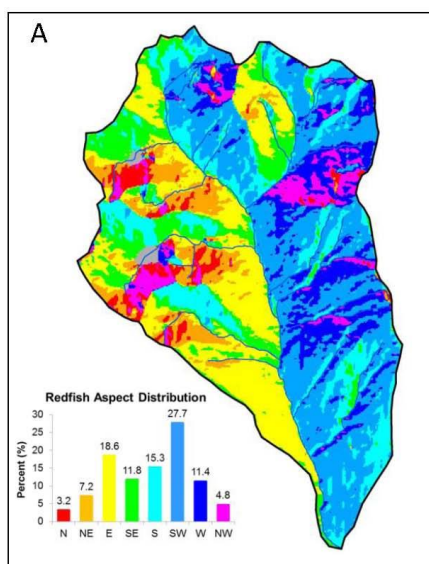
FIGURE 12. REDFISH CREEK ASPECT DISTRIBUTION

Rover Creek and Redfish Creek display substantial differences in physiography. Redfish Creek is roughly half the size of Rover Creek with steeper slopes that are predominantly south to southwest aspect (Figure 12) compared to the northeast/southwest contrasting

slope aspects in Rover. Given these differences, and based on the study outcomes, it follows that Redfish Creek is likely to display greater increases in the advance and rate of runoff following harvesting on south/southwest aspect slopes than would occur in Rover Creek for similar levels unless the majority of harvest in Rover were situated on south/southwest aspect slopes – which it is not. In addition, the Redfish

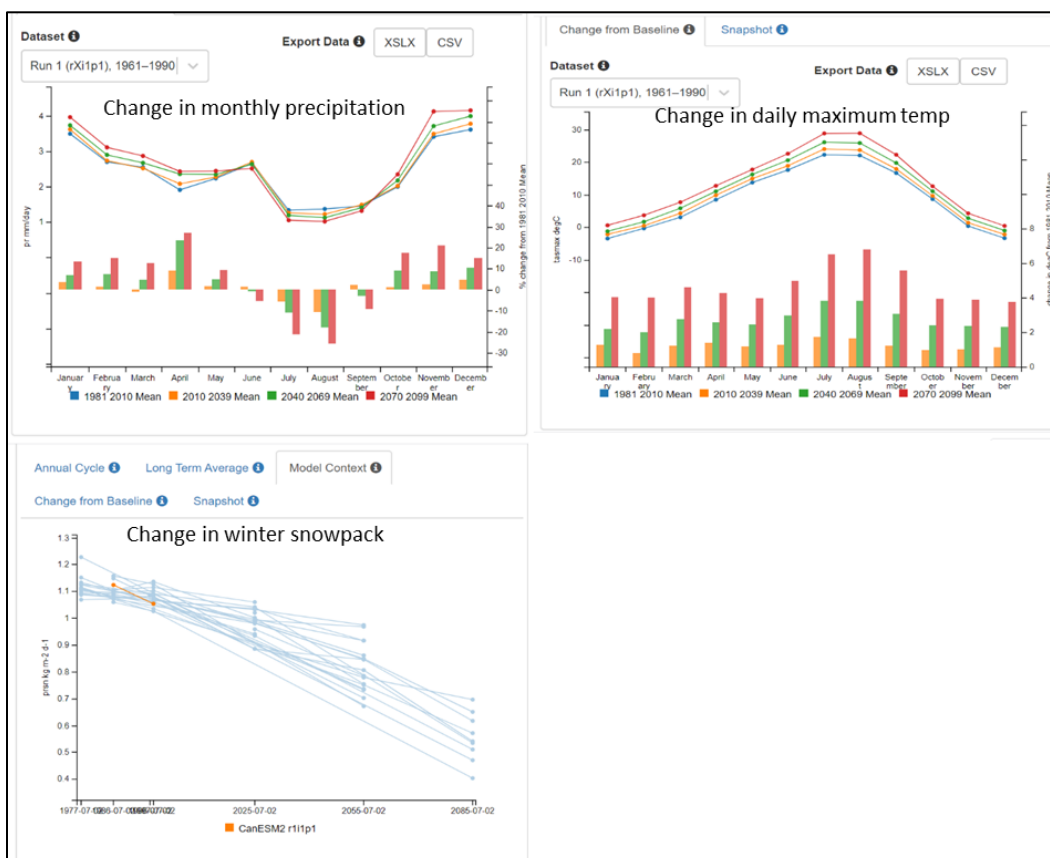
Downscaled climate models for the RCP 8.5W/m² (worst-case) scenario suggest that total winter and spring precipitation is likely to increase but that daily temperatures during the winter months will also increase by several degrees (Figure 13). As a result, by roughly 2070 Rover Creek could have a substantially lower snowpack, and be substantially snow free at the lower elevations (below appx 1500m) reducing the occurrence of large snowmelt or rain-on-snow floods and the turbidity events associated with these floods. However, these same trends will increase the likelihood of rain-on-snow peak flows and changes in the timing of runoff and duration of low flows. Due to the lack of discharge gauging in Rover Creek it is not clear the extent of the advancement of peak flows that may be occurring with climate change. In nearby long-term gauged Anderson Creek since gauging began in the late 1940's peak flows have advanced by, on average, 6 days but this is in part associated with a large area of beetle killed forest in the upper elevations. Although Anderson Creek is a lower elevation watershed than Rover Creek some of the earlier peaks in Rover could experience similar shifts or, more likely there will be more peak events earlier in the spring. However, the annual maximum peak flows, which are driven by high elevation snowmelt are unlikely to shift in timing assuming solar-radiation driven snowmelt remains the primary driver of annual maximum peak flows.

FIGURE 13.
TRENDS IN
MONTHLY
TEMPERATURE,
MEAN DAILY
MAXIMUM
TEMPERATURES
AND WINTER
SNOWPACK FOR
THE ROVER CREEK
AREA FROM PCIC
CLIMATE
EXPLORER TOOL.

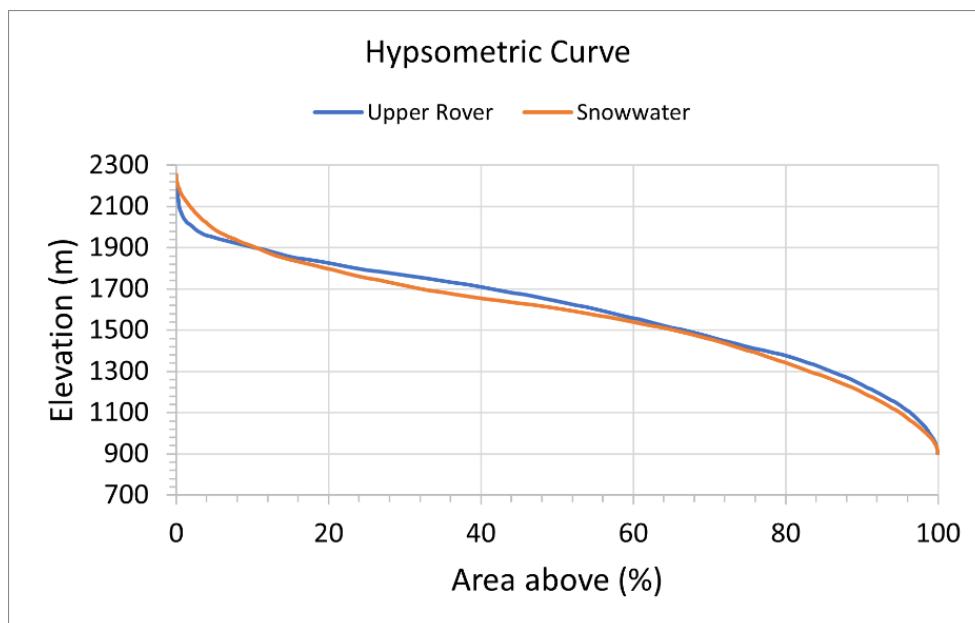
The hypsometric curves for Snowwater and upper Rover Creek are nearly identical with the H60 elevation in Snowwater Creek at 1540 meters and at 1560 meters in upper Rover Creek (Figure 14). For this more detailed analysis and as in Redfish Creek, the existing development in both headwater basins is considered with respect to their H80, H60 and H40 elevations (Figure 15, and Tables 6 and 7). However, because there is also forest development above the H40 elevation in Rover Creek, two 'upper forest' areas are included. Upper forest 1 is the H60 to H40 zone and upper forest 2 is the full area above the H60 elevation.

FIGURE 14. HYPSONETRIC CURVE FOR SNOWWATER AND UPPER ROVER CREEKS

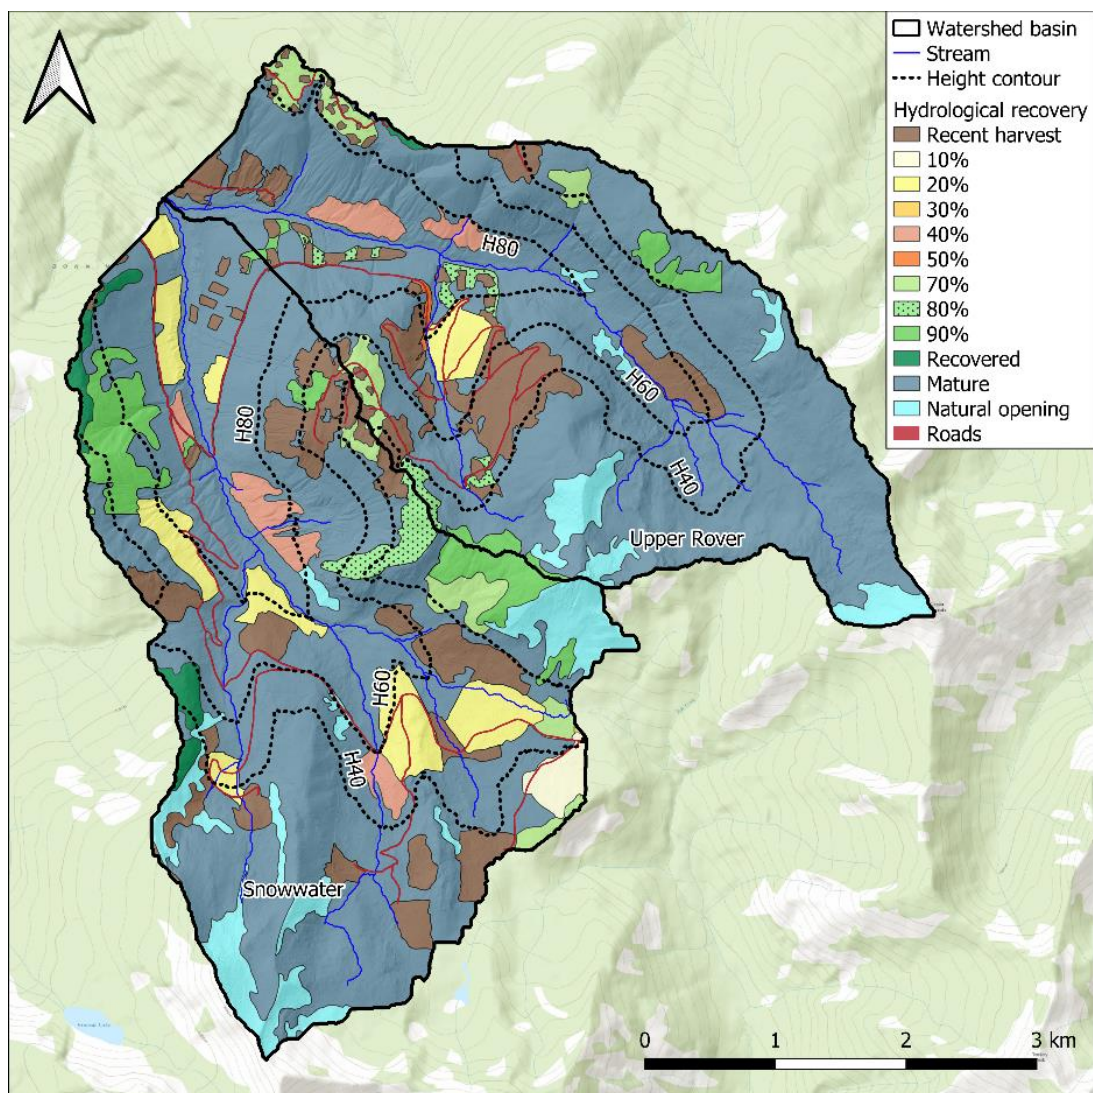
FIGURE 15. DISTRIBUTION OF CURRENT OPENINGS WITH RESPECT TO THE H80, H60 AND H40 ELEVATIONS.
